# DAM SURVEY CASE STUDY

KaarbonTech Surveying were commissioned to produce an aerial survey of the Norton Fitzwarren Dam. Our client, an Environmental company, who deliver renewable energy and waste management projects in both the urban and rural environments, are responsible for maintaining the dam.

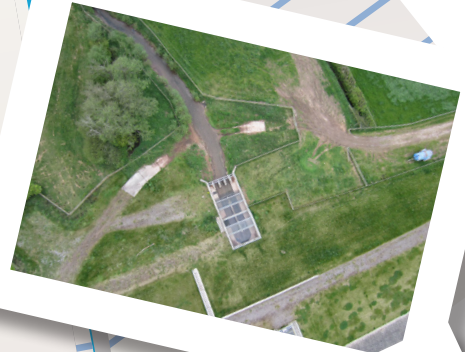
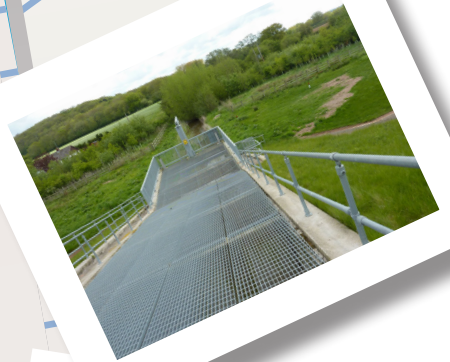
The resolution of the final imagery was 3cm GSD and this was then added to a CAD format and supplied to the client along with all the images of the flights.
